# Case Study

# St Richards House, Droitwich Spa

Major Repair Works

## Scope Of Works

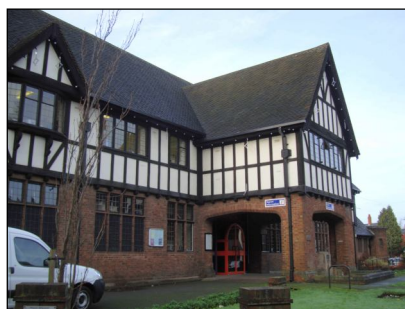
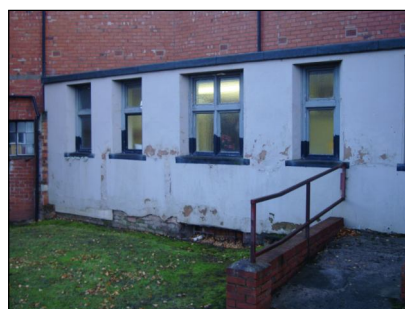
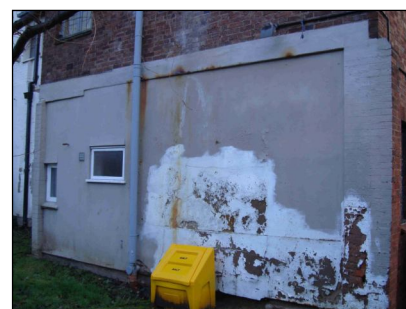
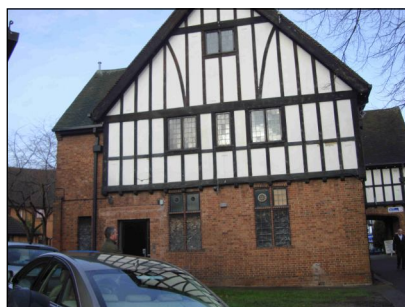
Due to the extent of Salt exposure and efflorescence, along with general day-to-day wear and tear, major repairs were required, including preventative treatment for future resistance to similar decay. Certain walls required a Chemical DPC to be provided. Specialist Salt retardant sealer was used to brickwork and Celotex Double-R Insulation utilised in order to meet current regulations and prevent future problems.

Remove and Replace Plaster Affected By Efflorescence; Render Panel Repairs / Decorating; Remove Render, Apply Salt Retardant Sealer to Brickwork, Apply Battens and Celotex Double-R Insulation and Re-Render in 3 Coat Render and Decorate; Replace Broken Bricks; Replace broken glazing panels; Internal Plaster Repairs and Decorations

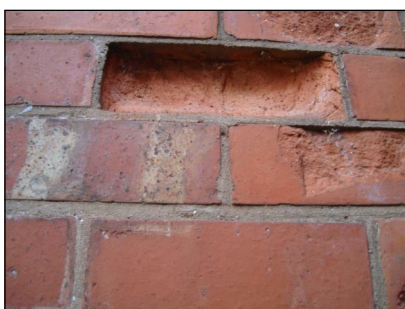
### **Remove and Replace Damaged Brickwork**

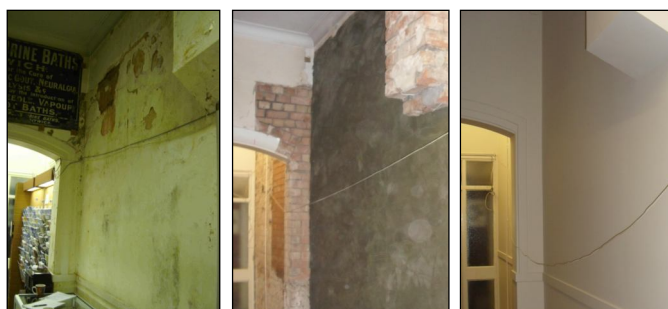
### **Remove and Replace Plaster Affected By Efflorescence**

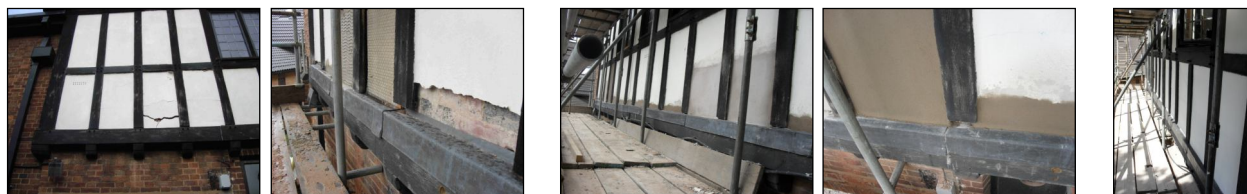
### **Render Panel Repairs / Decorating**

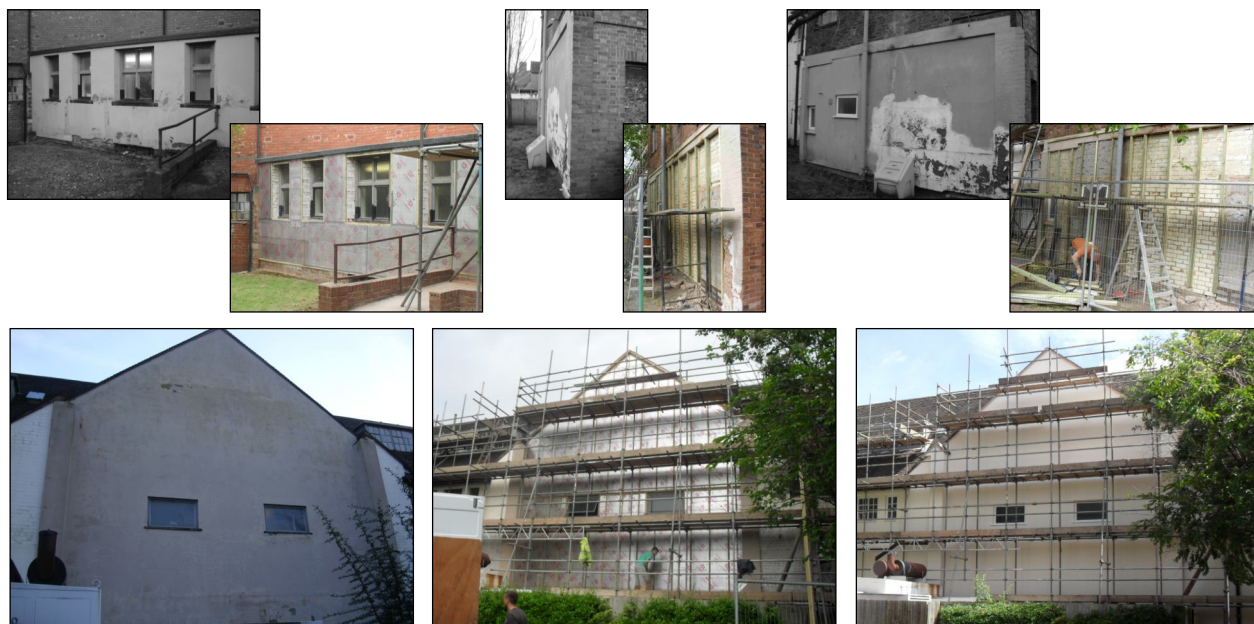
### **Remove Render, Apply Salt Retardant Sealer to Brickwork, Apply Battens and Celotex Double-R Insulation and Re-Render in 3 Coat Render and Decorate**
