# Case Study

# Beaumaris Castle, Anglesey

| <u>Type of Works</u> | Piling Support to Moat Wall |
| <u>Client / Customer</u> | OPUS (on behalf of CADW) |

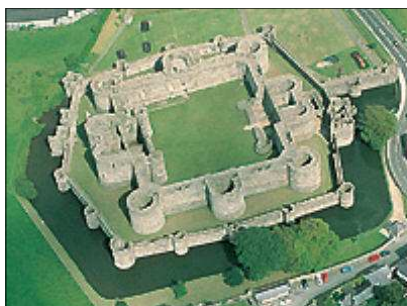
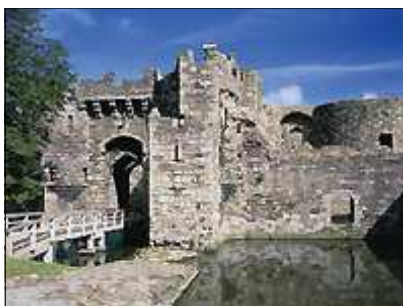
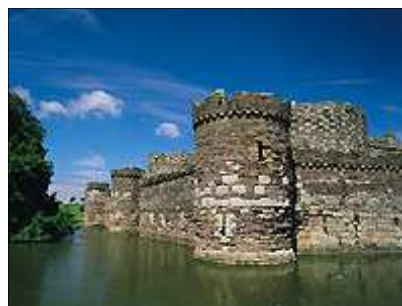
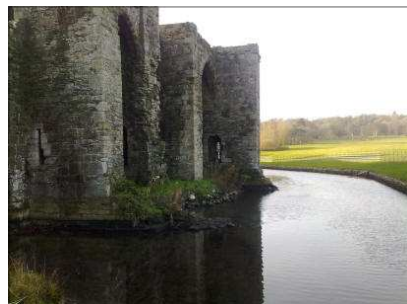
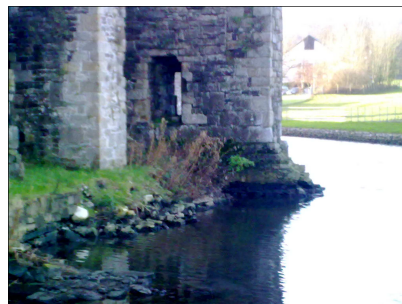
First, the moat had to be diverted in order to allow space and conditions suitable for the piling / reinstatement work. The existing collapsed stonework was carefully removed and stored on site for re-use where possible. Following removal of the stonework, the new piled foundations were installed, followed by a new concrete bank (ready for finishing in stonework)

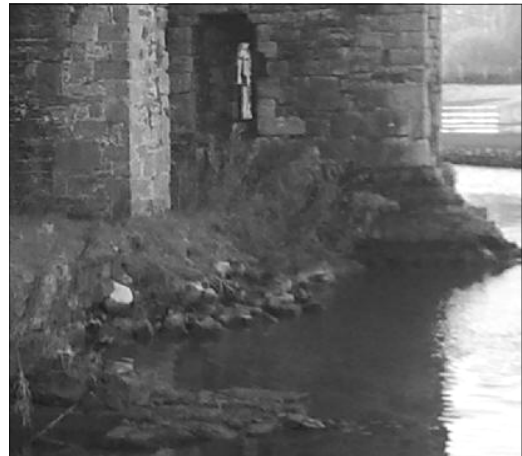
# EXISTING CONDITION

The last and largest of King Edward I's Welsh fortifications dating back to the 13th century, Historic Monument, Beaumaris Castle, was in desperate need of repair works to the moat wall, which had collapsed with the many hundreds of years of wear and tear from the moat and coastal conditions.

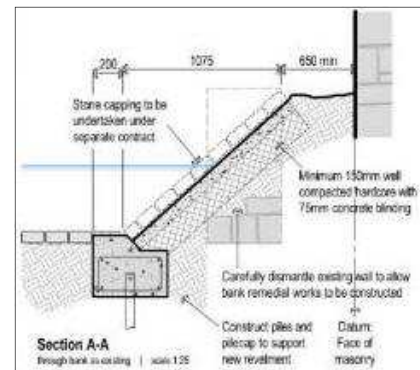
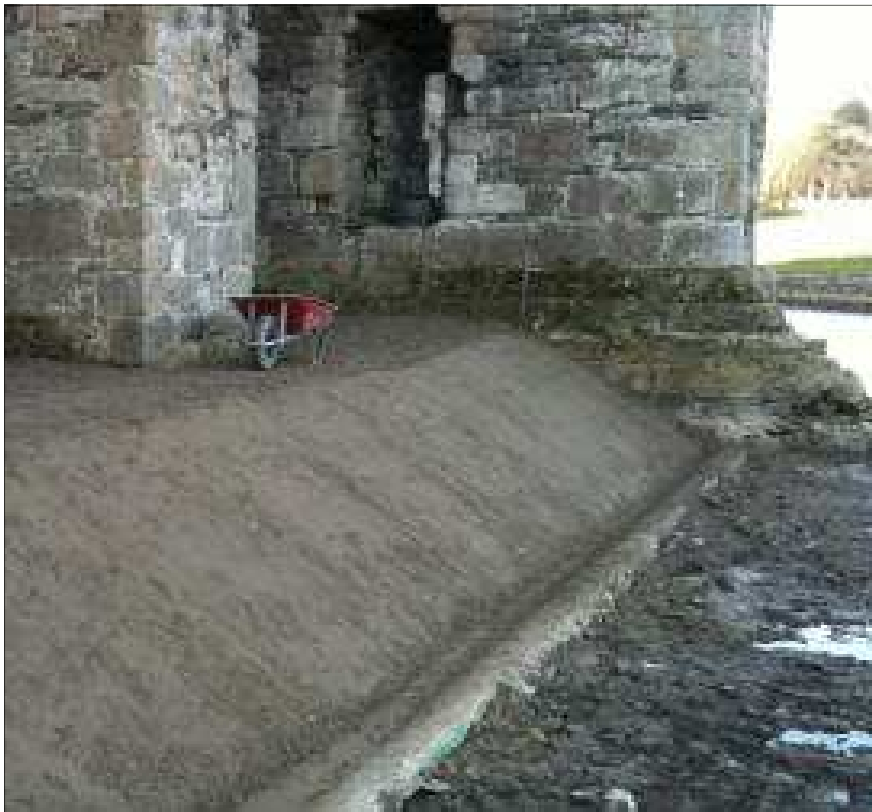
# PILING PROPOSAL

Antares Construction had previously recommended the use of Shire Piles to Opus International Consultants (working on behalf of CADW), and a design was drawn up for the use of this system to be used to stabilise the new foundations needed in order to re-build the collapsed moat walls in two locations around the site.
