# Case Study

# Birchlands, Bridgnorth

Piling / Crack Repairs

Piling to support foundations

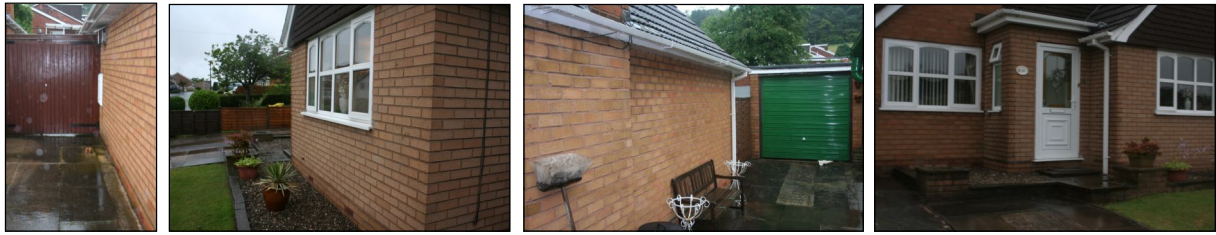
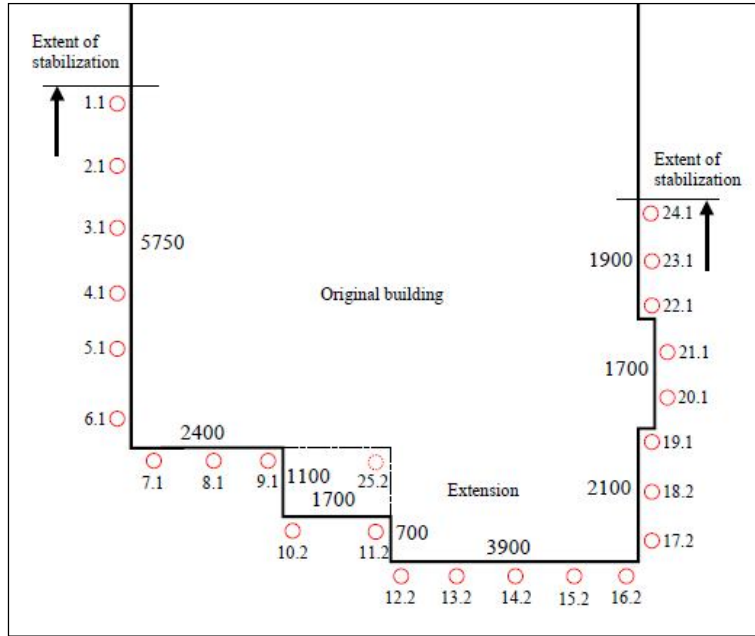
## Piling Works

Piling Works carried out to stabilize existing foundations.

A Professional Design was drawn up to ascertain the required positions, quantities and depths of the piles to be used.

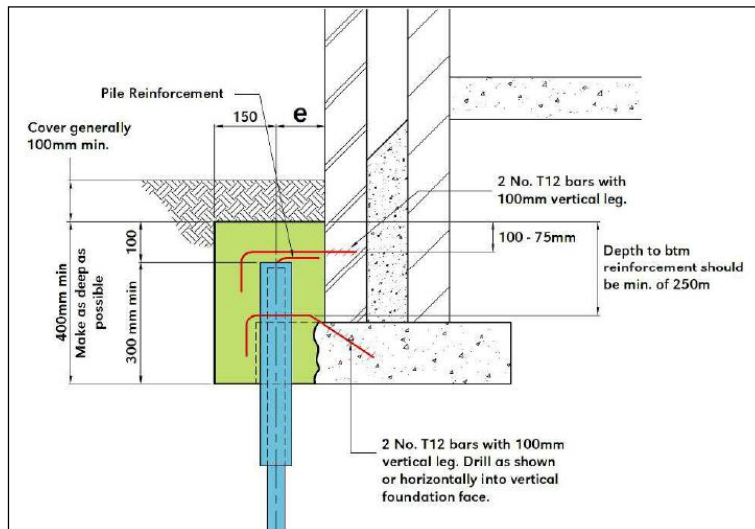
Following the Piling Works, the areas of paving slabs and tarmac were reinstated to match the undisturbed areas.

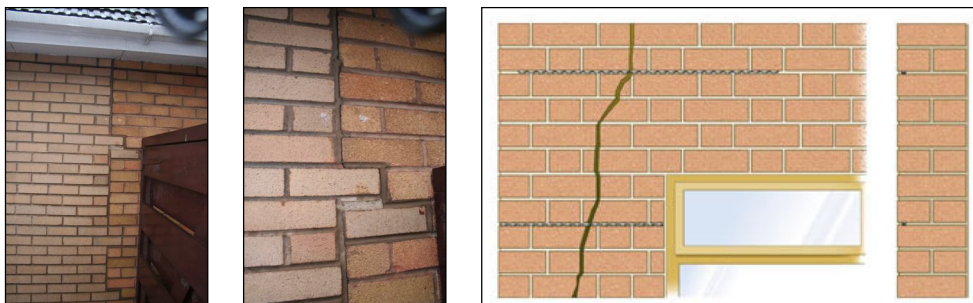
## Crack Repair Works

Crack Repairs were carried out to the external brickwork using Thor Helical Helibars.
